The Locomotive

THE HARTFORD STEAM BOILER
INSPECTION AND INSURANCE CO.

HARTFORD, CONN.
1912-1913.

Water Gage Glasses.

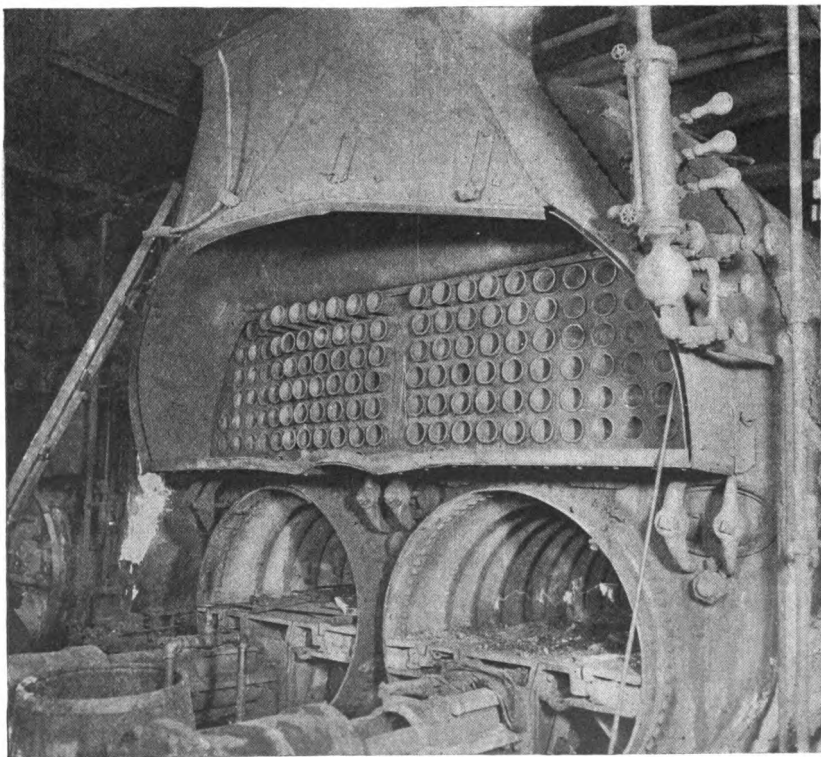
FIG. 1. DAMAGED FRONT OF BOILER.

From the data at hand the cause of this overheating cannot be definitely determined, but the boilers were reported clean, and if such was the case, forced driving or low water was probably responsible. Sheet "B" was thrown forward against the rear tube sheet "D" with such force that it drove a number of tubes through the front head, some of them extending as much as six inches from its face. This is shown on the accompanying view of the front of the boiler.

Three men were seriously scalded by this accident, one being so severely injured that he died shortly afterward. The property damage was chiefly confined to the boiler, with the exception of a brick wall located some distance in front, which was thrown down by the force of the explosion. The doors and hoppers of the boiler front were blown through a window twenty feet away.

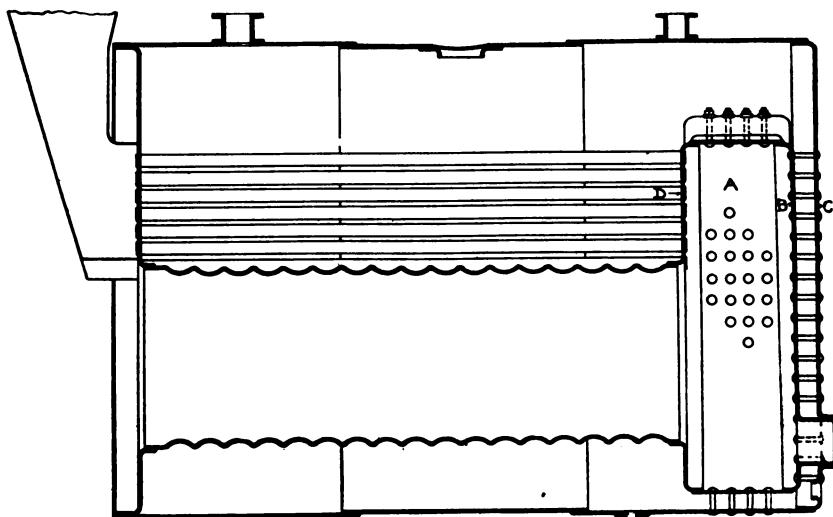
The vessel was what is known as a "wet back boiler." The general construction of such a vessel is shown by the line cut, Figure 2. The tubes and flues terminate in an internal tube sheet, "D," and communicate with a combustion chamber, "A," within the shell. The back of this chamber is formed by a sheet, "B," stayed to the rear head, "C." The space between sheet "B" and head "C" is filled with boiler water under pressure and gives the name "wet back" to the type. It was the bursting of this "wet back" and the consequent collapse of the combustion chamber that occasioned the disaster. Its initial cause was the pulling off of sheet "B" from the 172 staybolts which held it.

FIG. 2. SECTION OF BOILER.

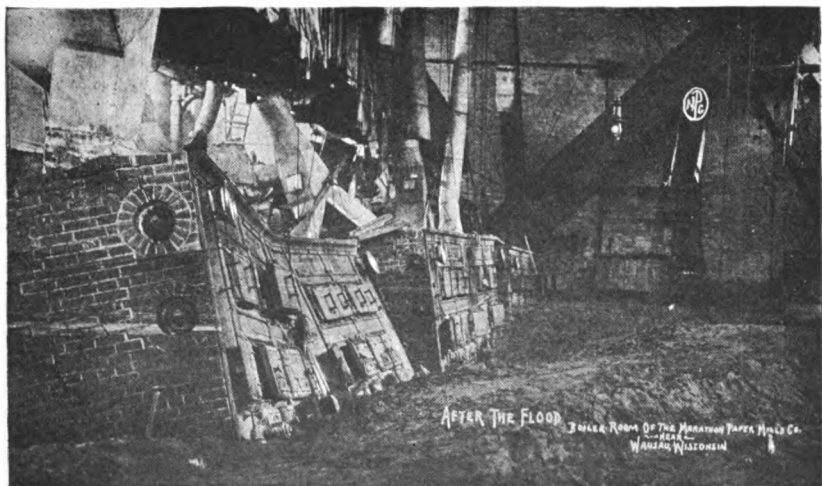
The accompanying illustration shows the condition in which the boiler plant of the Marathon Paper Company was left by a flood of the Wisconsin River, on which at Wausau, Wisconsin, that company's mill is located. Unusually heavy rains in the early part of last October had caused high water in all the streams of that neighborhood, and on the sixth of the month the Wisconsin had burst its banks and overflowed the Marathon Company's property, cutting new channels between its buildings, and as it developed, undermining the boiler foundations. Late in the afternoon of that day, before the water had reached the boiler room floor and while steam was still maintained, an initial settlement occurred in the end one of a battery of six boilers. This caused a break in a feed pipe by which three of the attendants were seriously scalded. Soon after the water invaded the room and operations had to be suspended. At 8:30 in the evening the foundation completely collapsed at the rear, wrecking the

WRECKED BY A FLOOD.

These pages have frequently described the circumstances of a wrecked steam plant, the cause of which was attributed to low water, but it is quite a novelty to record in them a case such as this, where the opposite condition must be held responsible for the misfortune.

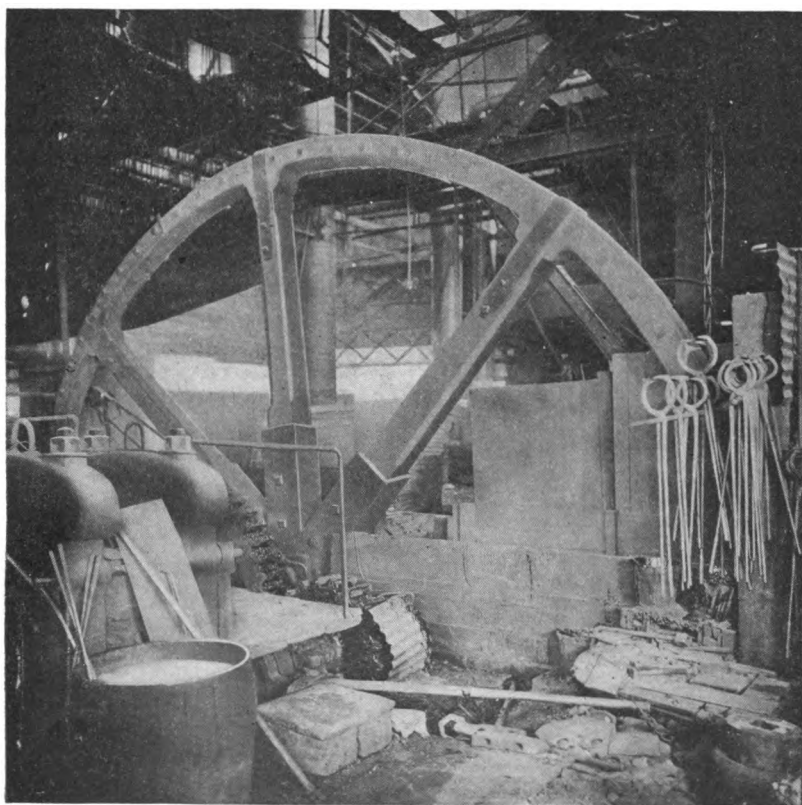
AN OLD FLY-WHEEL.

The illustration on the front cover of this issue of *THE LOCOMOTIVE* shows the wreck resulting from the failure, May 10, 1912, of a fly wheel on an engine of the high speed, simple, automatic type. The engine in question was a 12" x 12", center crank, and was belted to a generator at the Higginsville, Mo., electric light plant. This illustration is of particular interest, because of the widespread notion among engineers, that engines of the "automatic" shaft governed type cannot run away. A somewhat similar instance was recorded in *THE LOCOMOTIVE* for April, 1911.

It would appear that in this case the governor pulley failed first, and we are told that fragments went through the roof with considerable violence. This failure may have been hastened by a blow delivered to the rim of the wheel by the governor weight. When relieved of the first wheel, the engine seems to have slewed around on its foundation, fouling the other pulley on the sub-base, and shearing its spokes free from both the hub and the rim. This rotation of the whole engine is in the right direction (left handed), to be explained by the principles of gyroscopic motion. If we consider the crank shaft balanced for weight by the two wheels, when running normally, it would become immediately unbalanced by the failure of one of them. This failure would probably occur at high speed, and so is favorable to such an assumption. It is of course well known to those who have experimented with the simple gyroscopic tops of their school days, that if the wheel is spinning, the top may

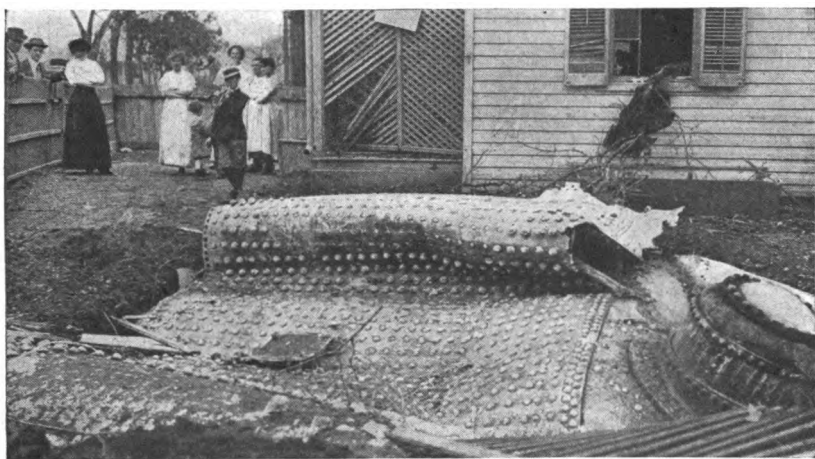
Reference to Figure 1 will show the general character of the explosion which resulted in the immediate death of 26 men and we are informed, in the subsequent death of three more, making a total of 29. It will be noted that the explosion apparently started in the firebox, which was blown directly down. The front head with many of the tubes attached will be seen to have been projected forward and to the right, while the wrapper sheet and part of the third course, carrying the dome, were blown backward some three blocks and were said by observers to have attained a considerable height, estimated to have been some 500 feet. These sheets, weighing some 6,000 lbs. landed in a dooryard and are shown in Figure 2. A glance at Figure 3 will show at once the terrific character of the explosion, and also the fact that the damage was much greater at the rear end of the locomotive than at the forward end, as one of the after drivers is seen to have been completely forced from the axle.

FIG. 2. WRAPPER SHEET AND DOME IN DOOR YARD.

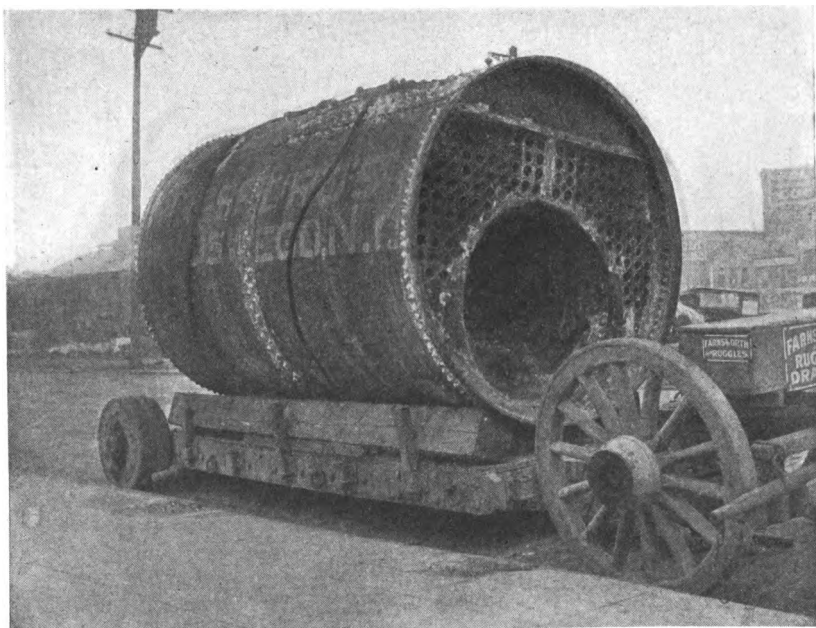
After the accident, the oil burner was turned off and the steam used up in propelling the dredger to the bank, getting its buckets on shore, and hauling the water and oil barges alongside, some twenty minutes being consumed in the operation. No one was injured.

FIG. 1. BOILER OF THE "THOR."

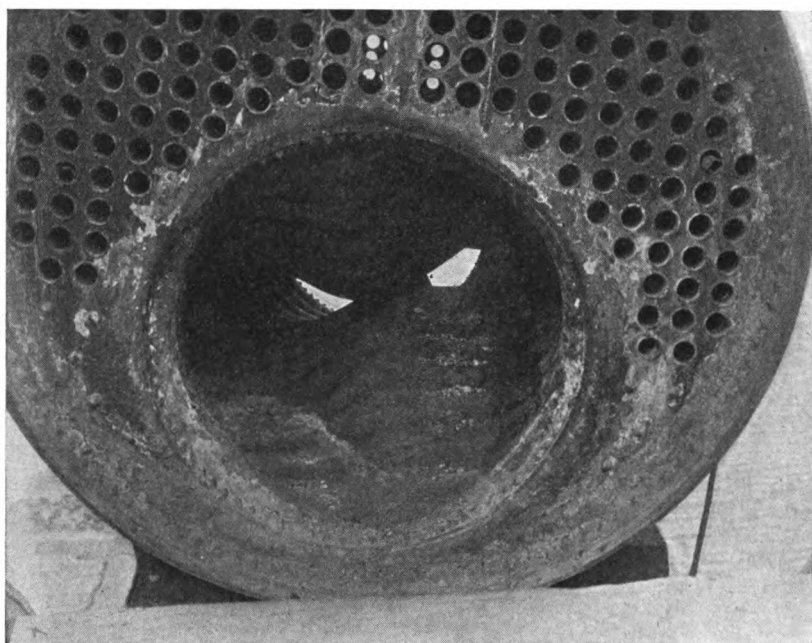
It would seem that this case is one of those preventable accidents which need not have occurred if the boiler had received regular and thorough internal inspections, as it is difficult to believe that a competent inspector could have failed to detect this particular trouble long before it reached the danger point. We understand that the boiler was comparatively new. No insurance was carried.

FIG. 2. THE COLLAPSED FURNACE.

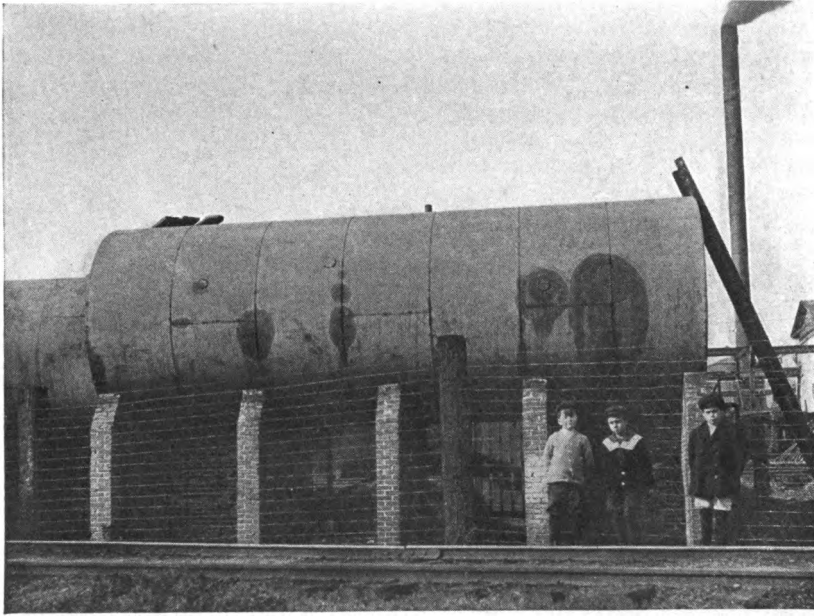
noise in the direction of the boiler house, but the performance was over before he could reach the scene. The cause of this peculiar action was never satisfactorily explained, and remains one of the mysteries of our Atlanta Department.

FIG. 2. THE PATCHED OIL TANK.

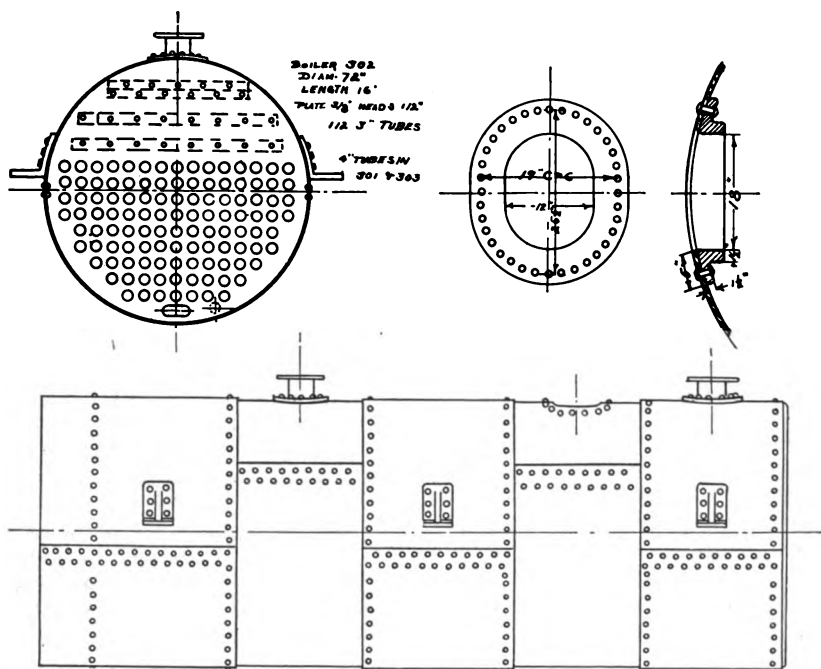
FIG. 1. DETAILS OF BOILERS 301, 302, AND 303.

The report of the HARTFORD's inspector shows that these boilers, aside from age were in apparent good order. There was evidence that no rivets had been replaced, and that the seams had never been chipped and caulked. No fire cracks were visible, and although there was a slight indication of overheating on the bottom sheets of the rear courses, this was considered trivial. The only repairs known to have been made, were several complete renewals of the tubes.

These boilers had been designed for a pressure of 100 lbs., but owing to the low factor of safety which they would have at this pressure, due to the low efficiency of the longitudinal joints, they had been worked at a pressure of 80 lbs. At this pressure, the actual factor of safety, based on the pressure of 260 lbs. at which the manhole frame of boiler No. 301 failed was only 3.25.

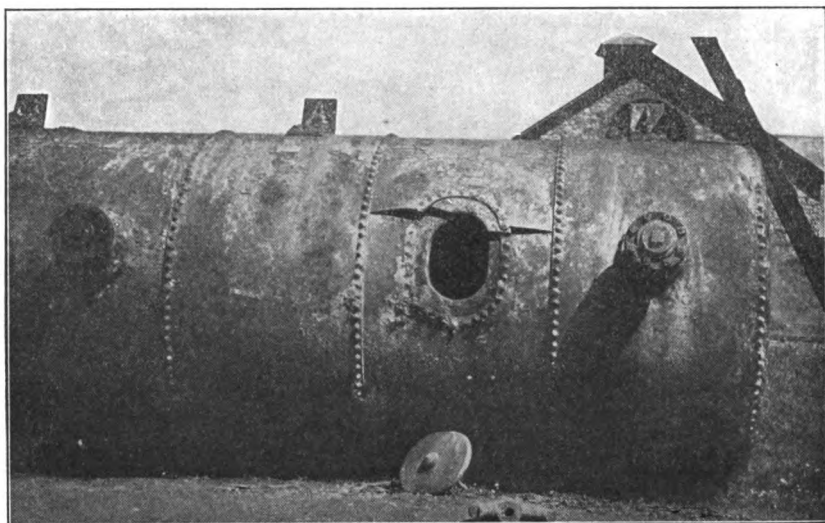
FIG. 2. SHOWING THE BROKEN MANHOLE FRAME OF BOILER 302.

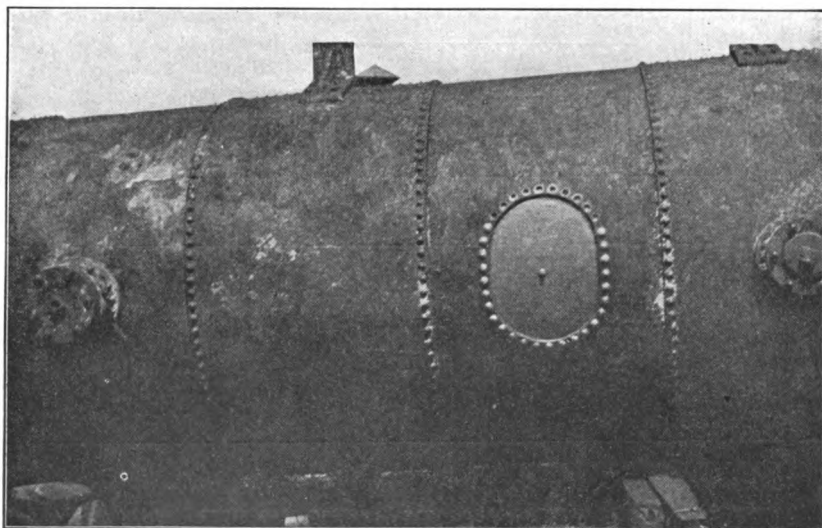
Boiler No. 303 was tested the following day, and in order to find if possible other sources of weakness, the manhole frame was removed, and the open-

FIG. 3. APPEARANCE OF BOILER 303 AFTER TESTING.

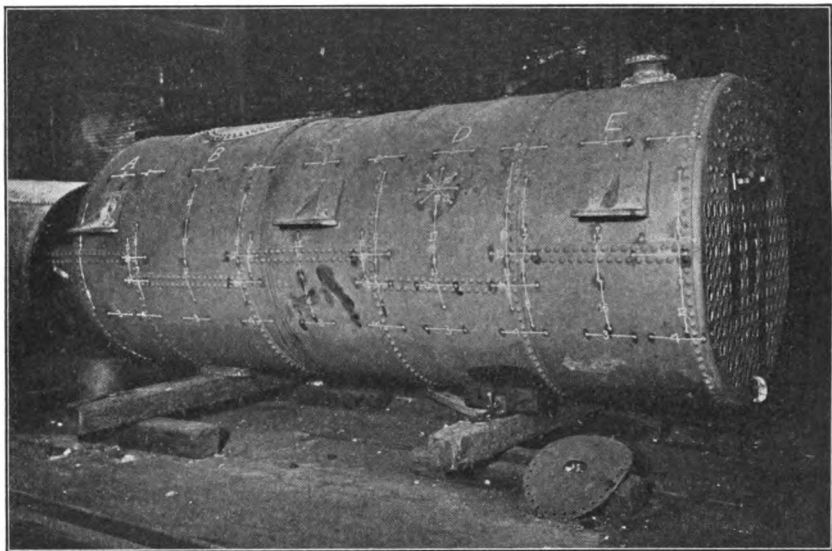
FIG. 4. BOILER 4092 PRIOR TO THE TEST. NOTE THE 10-INCH GAGED LENGTHS.

sheet. Their appearance prior to the test is shown by Fig. 4. The longitudinal joints were double riveted lap seams, $\frac{3}{4}$ inch rivets, pitched 2 inches, placed in punched holes. The plate thickness was $\frac{3}{8}$ inch for the shell, and $\frac{1}{2}$ inch in the heads. Both boilers contained 140 three inch tubes. Domes 2 feet 6 inches in diameter were provided on the second course, and cast iron man-hole frames and safety valve nozzles were fitted to the middle and rear courses, respectively. Both boilers were made at the shops of the Whittier Machine Co., Boston, Mass., in 1881, of "Benzon" steel. They were known as No. 4084 and No. 4092 on the HARTFORD's records, and were designated by these numbers in the report of the test published in the November 1911 number of the Journal of the American Society of Mechanical Engineers.

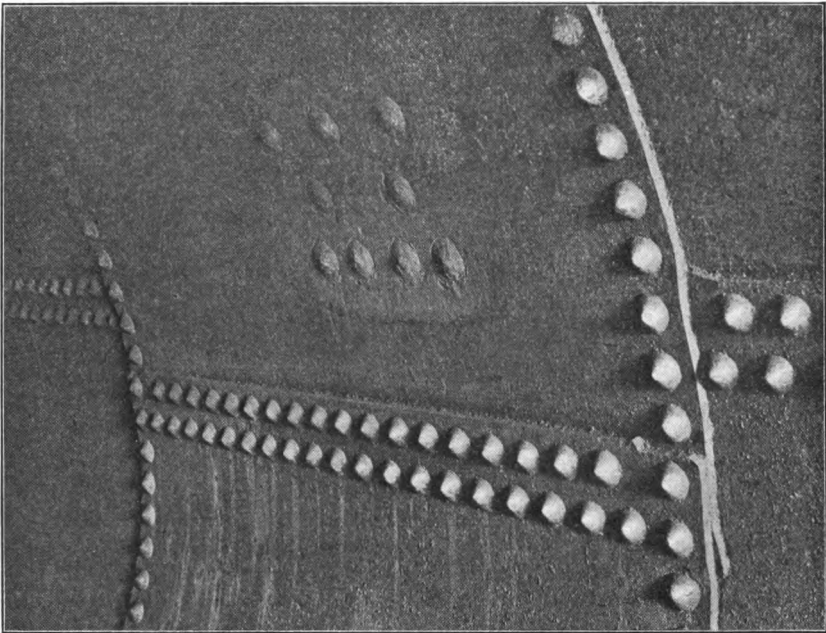
In the hope of attaining higher pressures, boiler No. 4092 was strengthened prior to the test, by removing the dome and manhole frame, and replacing them with patches. The safety valve nozzle was allowed to remain, but as the test progressed, it was found necessary to replace it with a soft patch, as it was impracticable to caulk the leaks occurring at its junction with the shell. Six $1\frac{1}{4}$ inch through stays were also added to give additional support to the segments of the heads above the tubes.

FIG. 5. SHOWING THE EVIDENCE OF DISTRESS UNDER THE LUGS AND AT THE LONGITUDINAL JOINT.

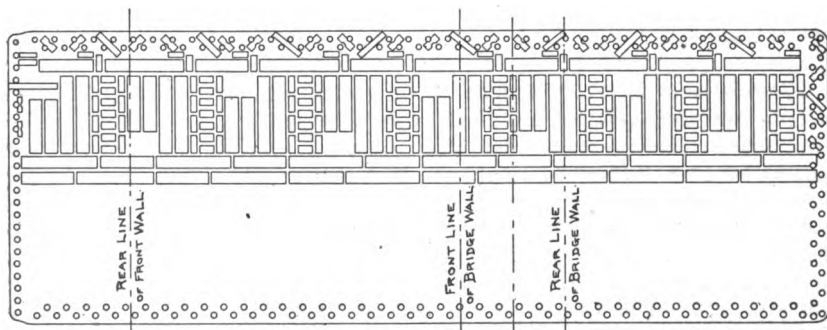
FIG. 8. FIRE SHEET OF C. SAY ET CIE. BOILER NO. 2. SHOWING THE LOCATION OF THE SPECIMENS WITH RESPECT TO THE FIRE.

Untreated Specimens.	Reheated Specimens.	Reheated and Quenched Specimens.
SPECIMENS FROM PORTION OF SHEET PROTECTED BY FRONT WALL.			
Tensile strength.....	53,500	53,900	none tested
Elongation.....	25.2%	26.5%	none tested
SPECIMENS FROM ABOVE THE GRATES.			
Tensile strength.....	53,500	53,800	70,000
Elongation.....	23.0%	27.1%	20.6%
SPECIMENS FROM OVER BRIDGE WALL.			
Tensile strength.....	51,300	52,900	70,700
Elongation.....	24.7%	26.5%	19.7%
SPECIMENS FROM BEHIND BRIDGE WALL.			
Tensile strength.....	51,400	51,500	68,700
Elongation.....	24.8%	30.2%	21.2%

Cold bend test of 38 specimens, fairly satisfactory. The real extent of the change in this boiler steel was not disclosed until the impact tests were made. 162 impact specimens were tested all told, but as 10 of these were in the nature of special tests, to determine the effect of various sorts of abuse on

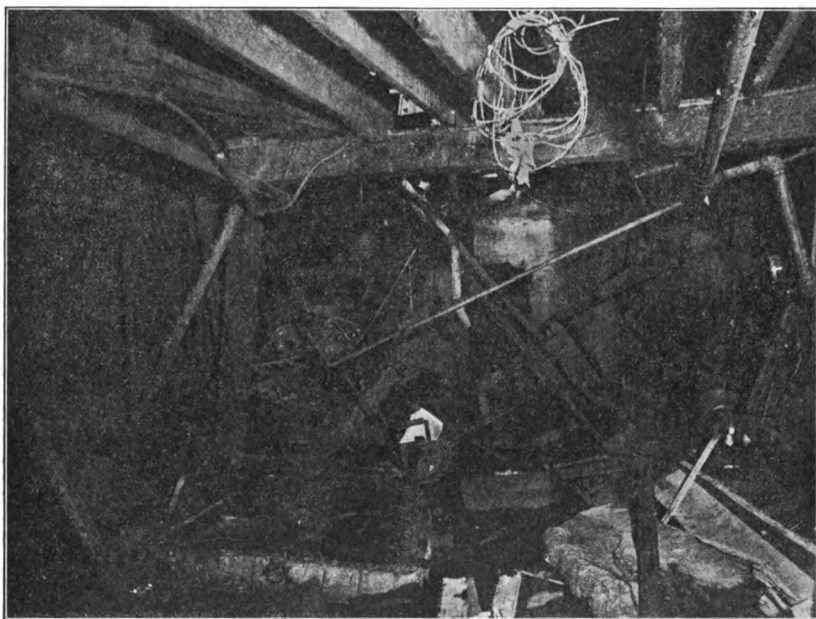
FIG. 1.—THE WRECKED BOILER ROOM, SALEM BANK AND TRUST COMPANY, SALEM, ORE.

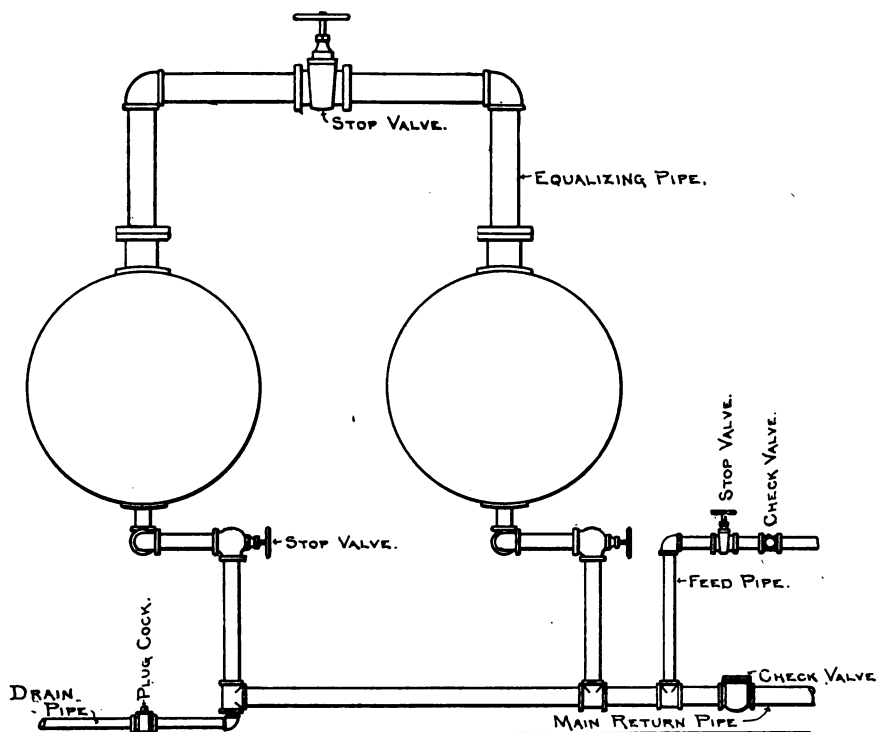
FIG. 1.—ARRANGEMENT OF RETURNS WITH EQUALIZING PIPE.

The return pipes of the various boilers should be connected to a common return line, with stop valves for each boiler. A check valve should be placed in the return line on the building side of the branches to the boilers as shown in Fig. 1, to prevent water flowing back to the radiators and piping when the main steam valve is closed, as discussed in the October 1912 LOCOMOTIVE. There

should not be any check valves in the branches to the boilers, since the return pipe acts as an equalizer below the water line and should afford a free connection between the boilers at all times unless the special condition described below exists, requiring the closing of the equalizer valves. If only one of a group of boilers is working on the system, the equalizer must be shut off if the dead boilers are cut off from the steam and return lines. If, however, the dead boilers are still connected to the system whether or not their fires are burning, the equalizer (and return valve) must be open to prevent the dead boilers from filling with water at the expense of the one which is working. This would probably result in serious over heating of the metal of the working boiler.

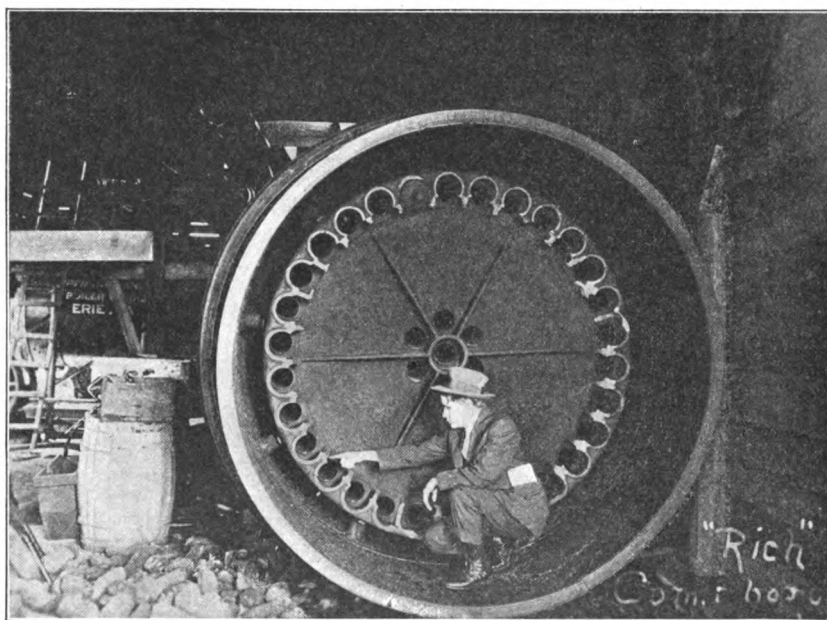
FIG. 3.—THE INSIDE OF THE EXPLODED DRYER HEAD.
THE MAN IS POINTING TO ONE OF THE OLD BREAKS.

safety valve or proper drain connection. This would indicate several possible reasons for its failure. The fact that it was inadequately drained would have permitted it to fill with water up to the level of the central axis when idle, and when steam was turned on a violent water hammer might have been produced. Then it could easily have been subjected to a severe and unknown over pressure, due to the absence of the ordinary safety devices. The very violence of the explosion, which killed three men and seriously injured a fourth, and which carried the heavy head seen in Fig. 2 a distance of 350 feet—the head was said to have weighed some 1200 lbs.—would indicate that the vessel must have contained considerable water which added its heat energy to that in the steam, when the explosion occurred. A number of old and deep cracks were found in the reinforcing webs which surrounded the tube ends in the outside row. The man seen in Fig. 1, is pointing to one of them.

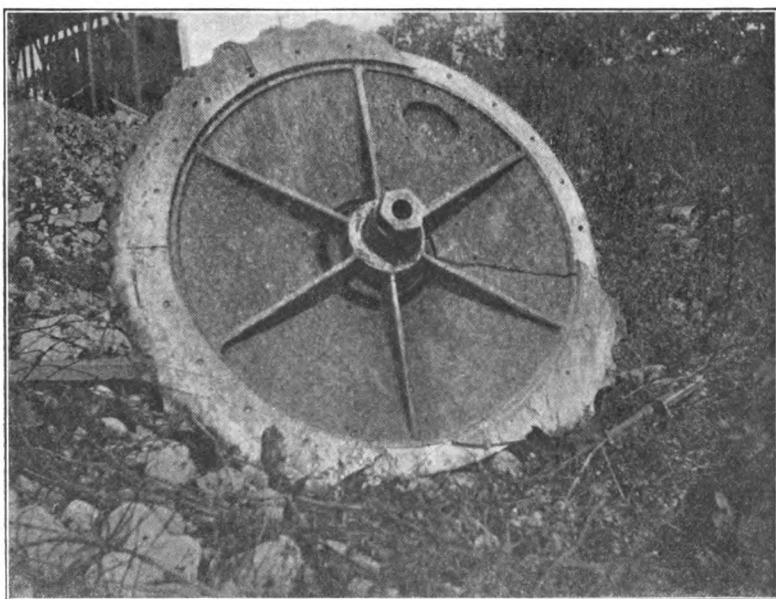
FIG. 3.—REVERSE SIDE OF OUTER HEAD.

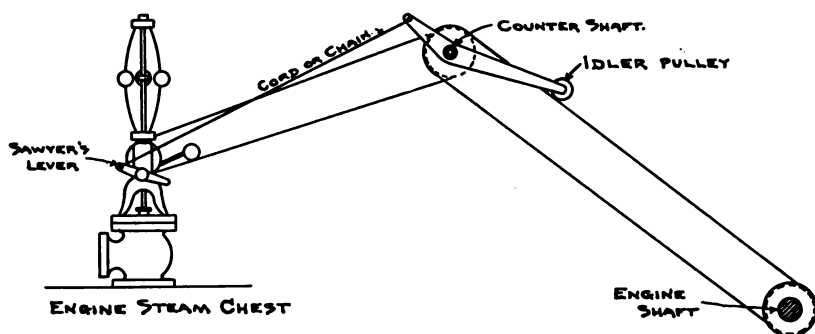
FIG. 1.—SAFETY DEVICE FOR A COUNTERSHAFT DRIVEN GOVERNOR.

When conditions compel the use of a counter-shaft with an additional belt to drive a throttle valve governor, it is very important that precautions should be taken to insure free action of the automatic safety stop. So that it will stop the engine if either of the two belts should break. So many cases have come under our observation where no provision has been made for such an emergency, that it may be well to call attention to the proper way to connect up governors operated in this manner. Of course, it will be understood that reference is now made to the throttling governor with an automatic safety stop attachment. This safety stop is designed to be operated by an idler pulley, which rides on the governor belt, and is so arranged that should the belt break, the idler will drop to a lower position, thus tripping the safety latch, and allowing the throttle valve to close.

When it is necessary to use two belts, as noted above, it is evident that the automatic safety stop on the governor will not operate if the belt that runs from the engine shaft to the counter-shaft should break. In this case, the governor would stop revolving and drop to its lowest position, allowing full steam admission to the cylinder, which would result in the engine racing. To obviate this danger, a second idler pulley similar to the one attached to the governor should be provided to operate on the belt leading from the engine to the counter-shaft, as shown in the accompanying sketch. This can be fitted with very little trouble or expense by the engineer or other mechanic about the plant, as the outfit only consists of the pulley and arm with cord or chain to attach to the Sawyer's lever on the governor, which also operates the safety stop. When thus connected, the governor can then be relied upon to stop the engine if either of the belts break.

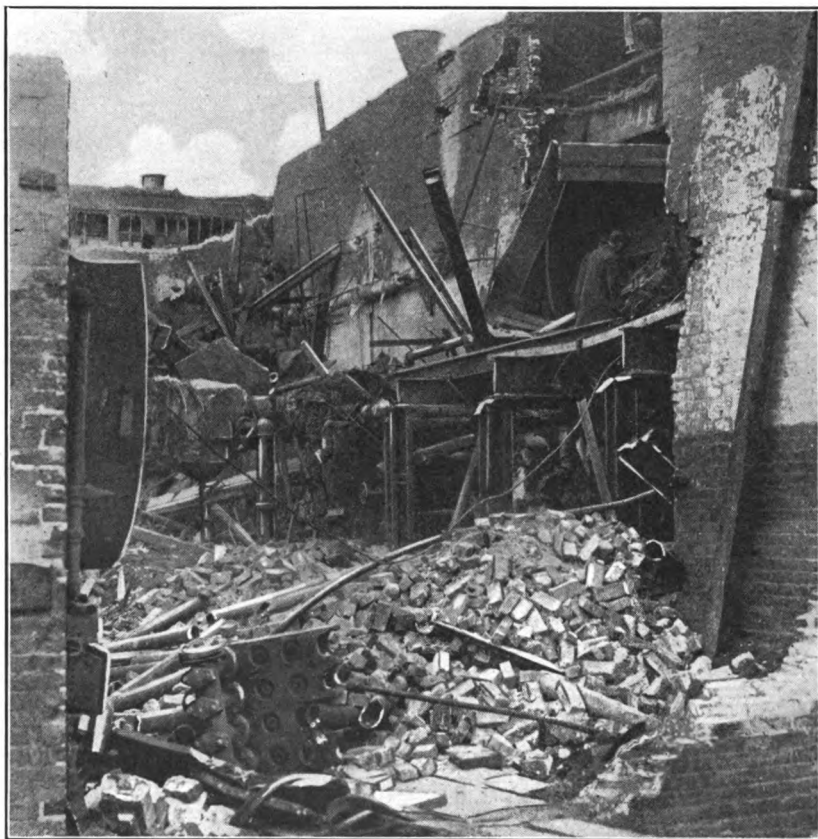
FIG. 5. A NEAR VIEW OF THE WRECK. ECONOMIZER EXPLOSION AT SAYLESVILLE, R. I.

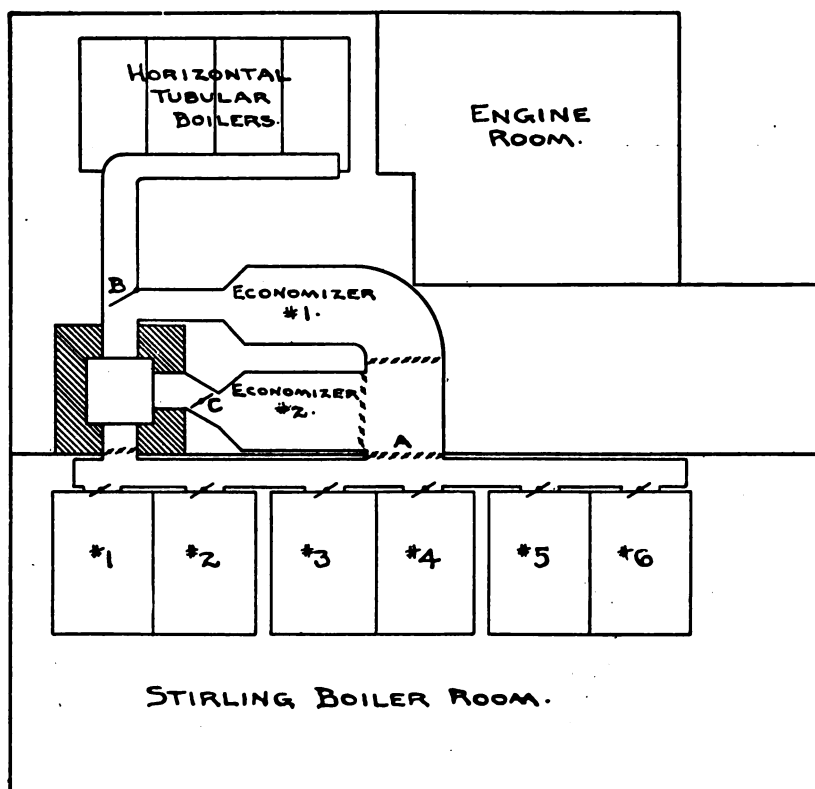
FIG. 1. PLAN SHOWING ARRANGEMENT OF BOILERS AND ECONOMIZERS.

The arrangement of the boiler house and its equipment, as it existed before the accident, is shown in our sketch plan, Fig. 1. There were two boiler rooms, one containing six 325 horse-power Stirling boilers, and the other containing the stack, the economizers, and a battery of four horizontal tubular boilers, together with the feed heaters, pumps, fans, fan engines, and other boiler room auxiliaries. As will be seen, only the gases from the Stirling boilers could pass through the economizers, while those from the tubular boilers went direct to the stack. The economizers, two in number, were behind the stack, and side by side, parallel to the division wall. They rested on a platform about 10 feet above the floor. This platform consisted of longitudinal I beams, between which were turned brick arches, and these in turn rested on transverse I beams,

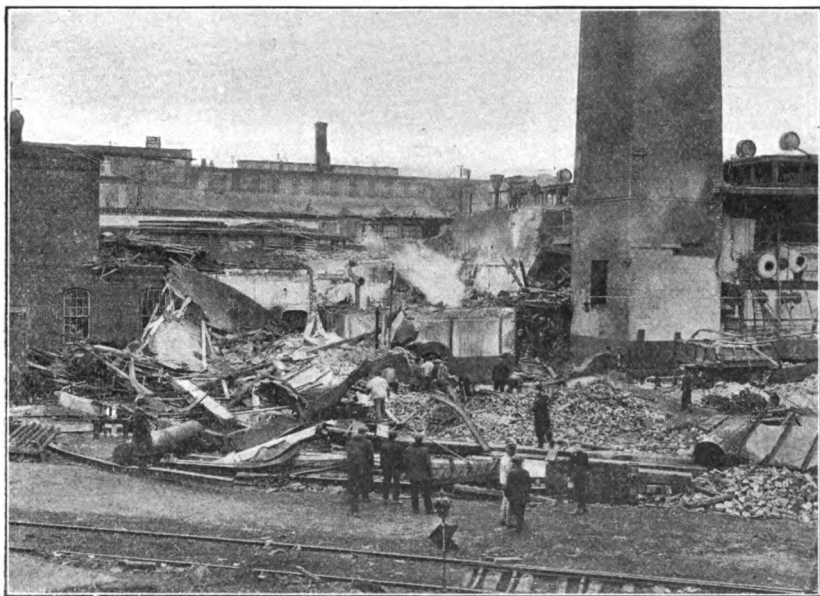
FIG. 2. GENERAL VIEW OF THE WRECKAGE.

The force of the explosion is perhaps best shown in Fig. 2. The walls of the tubular boiler room were all either thrown down, or so badly shattered as to necessitate being torn down afterwards. The end of the Stirling boiler room toward the roadway was also nearly all blown out. The idle or No. 1 economizer was blown all over the premises. Small pieces shattered ventilators, skylights, monitors, and roofs over a considerable area, while the roof over this boiler room was completely demolished. The platform which supported the No. 1 economizer was entirely blown down. Fig. 3, which shows a pair of 15 inch I beams, that served as transverse supports for this platform, at about the middle of the length of the economizer, will indicate somewhat the force of the blow. No. 2 economizer, which was working at the time, was shattered so as to be a complete loss, but it remained on top of its platform, which latter was practically intact. This is well shown in Figs. 4 and 5. It seems to prove quite conclusively that No. 1 was the actual exploding vessel. Furthermore, the resistance offered by No. 2 to the explosion, while it wrecked it (No. 2) completely, undoubtedly saved the Stirling boilers. Aside from some damage to their flue,—and that of a character which was easily repaired,—

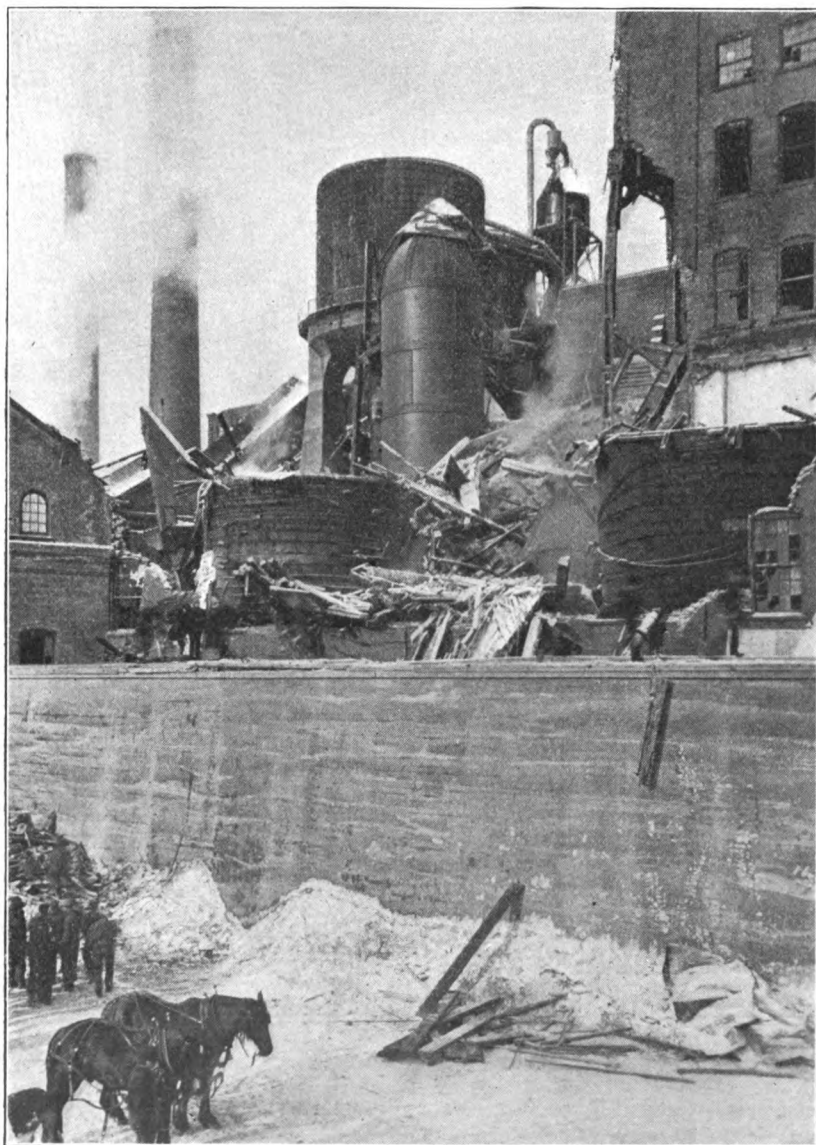
FIG. 1. GENERAL VIEW OF THE DESTRUCTION AT GRAND MERE.

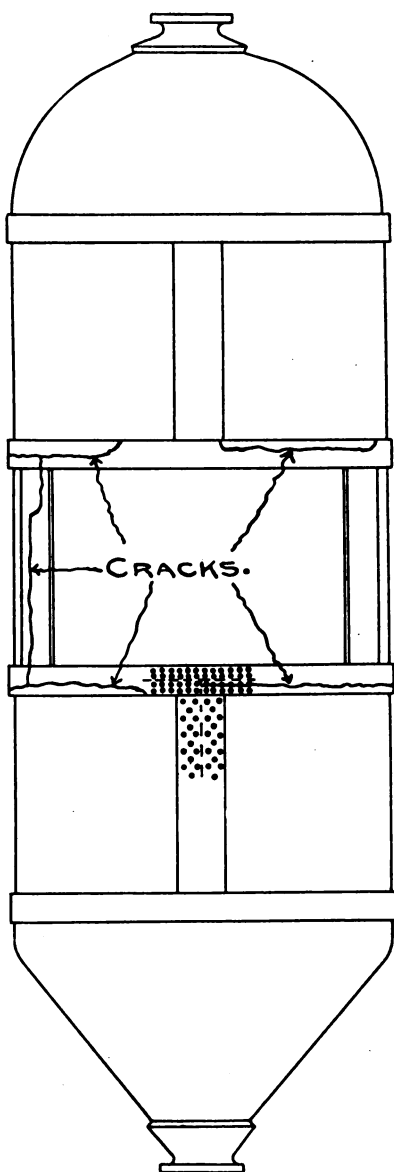
FIG. 3. ELEVATION OF DIGESTER SHOWING LOCATION OF THE LINES OF FAILURE.

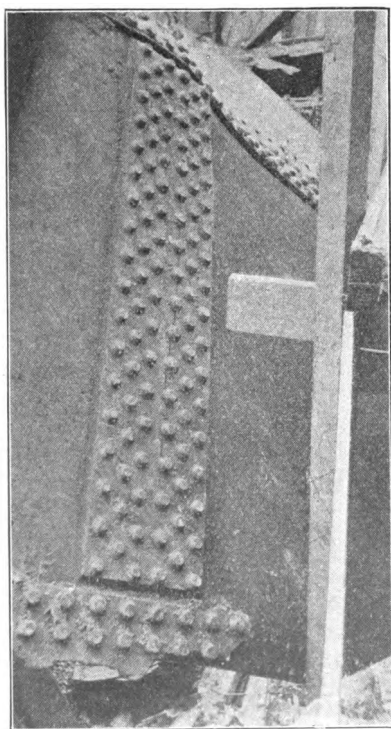
FIG. 5. CRACKED BUTT-STRAP.

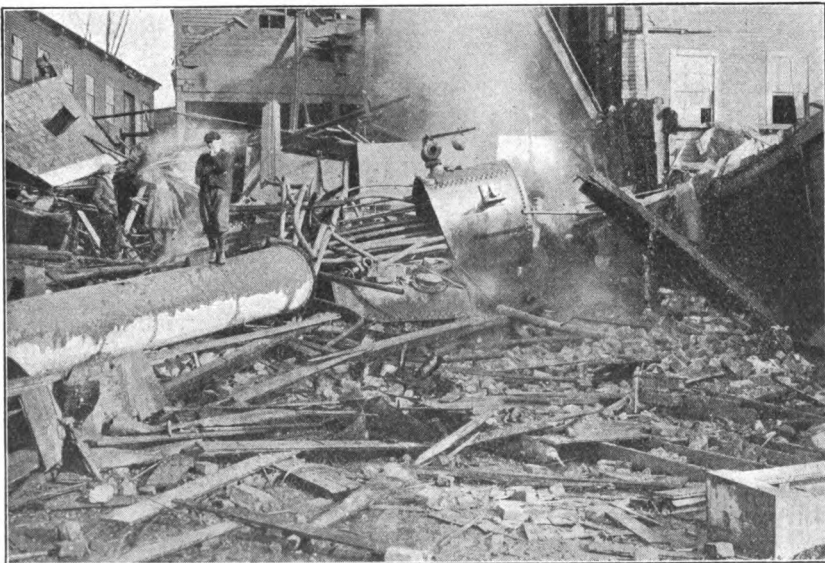
FIG. 1. BOILER EXPLOSION AT KEENE, N. H.

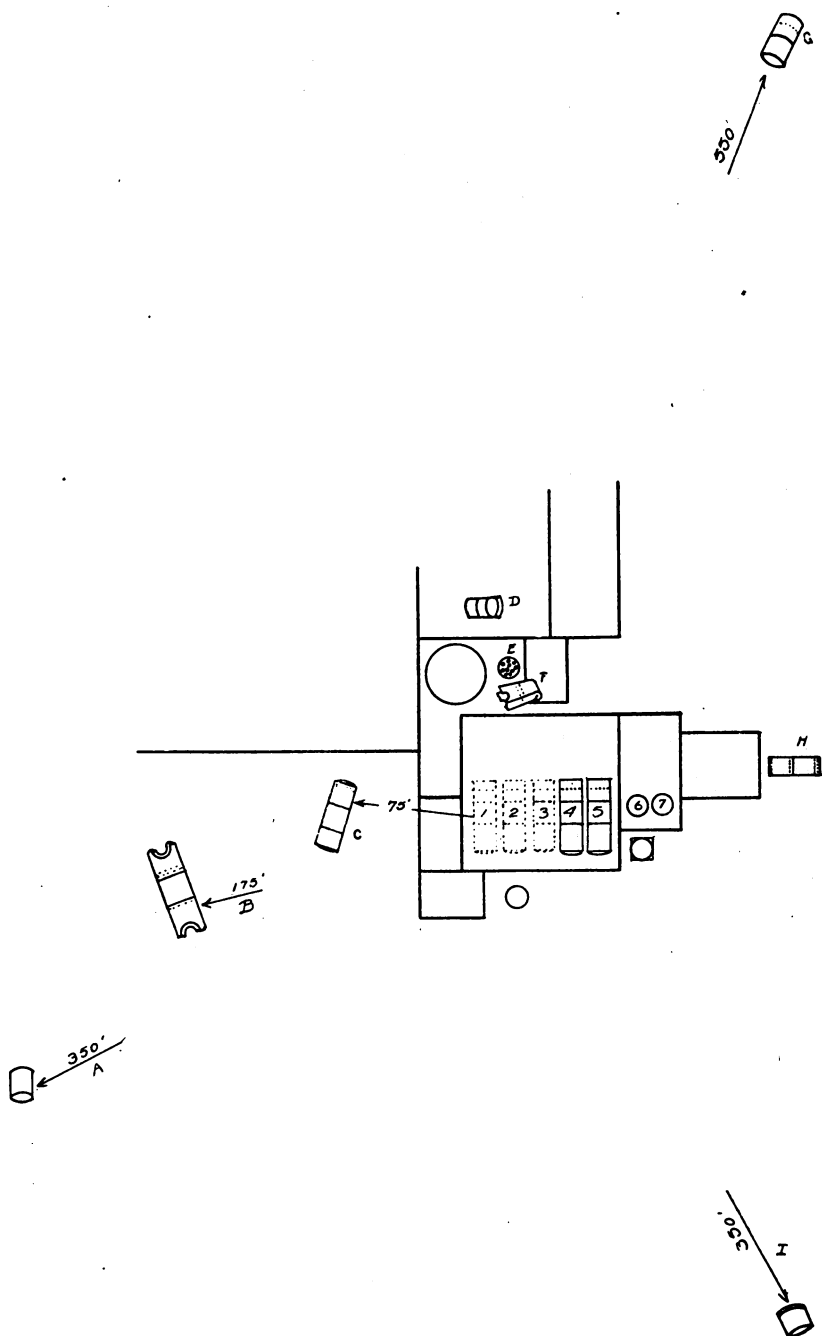
FIG. 1. PATHS OF PROJECTED BOILER COURSES.

There is some doubt as to which of the boilers first gave way. Witnesses testified to a double report like two pistol shots in rapid succession. It is probable, from the appearance of the failures, that one of the boilers exploded first, and struck its neighbor a blow of sufficient violence to set it off. Both the exploded boilers were of lap seam construction, built in five courses with outside cast iron man-hole frames attached to the third course. Both of them failed through the man-hole frame, and each man-hole course was ripped longitudinally from girth seam to girth seam, through the center line of the man-hole open-

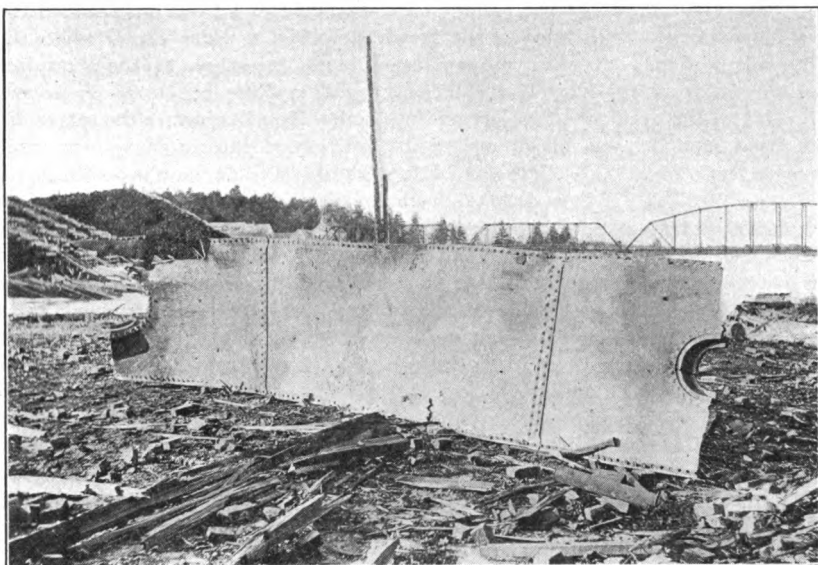
FIG. 3. RUPTURED MANHOLE COURSE "B."

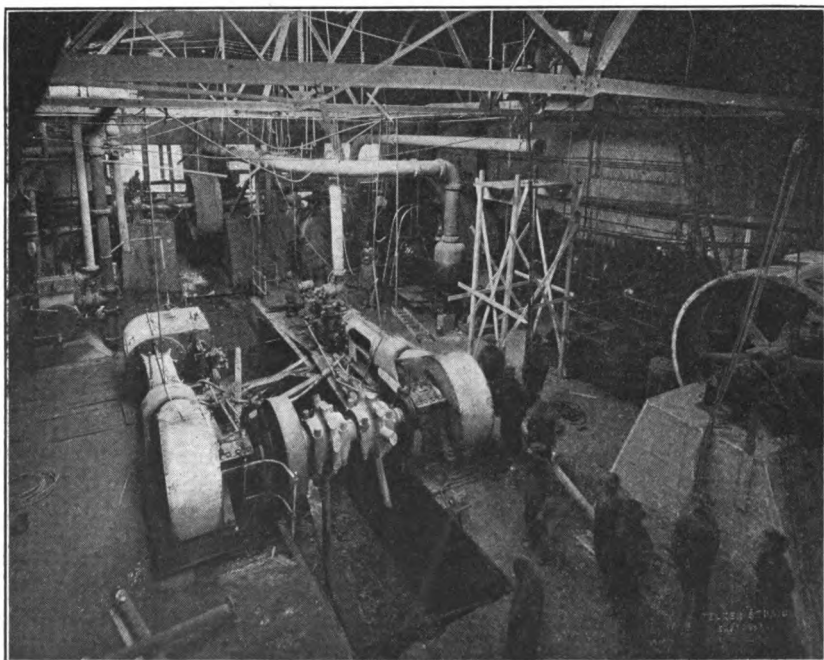
FLY-WHEEL WRECK, ALPHA, N. J.

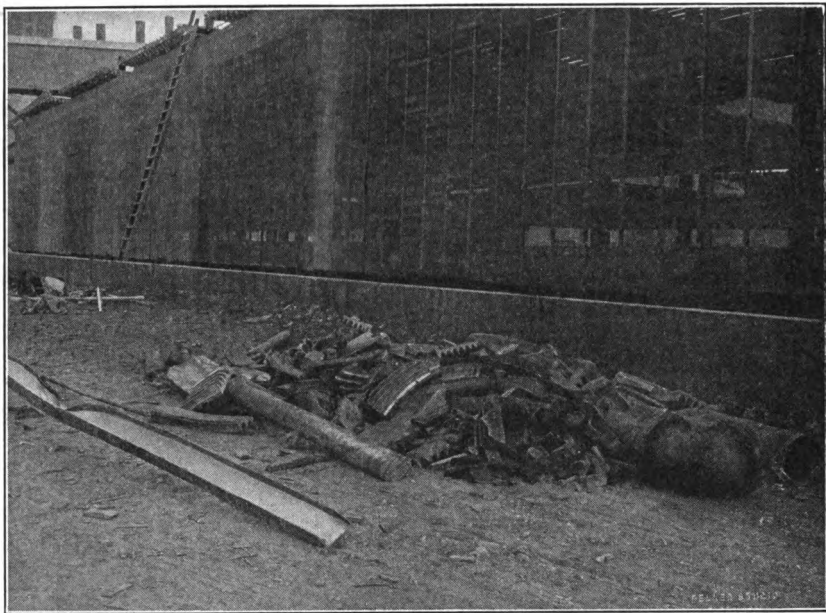
THE REMAINS OF THE FLY-WHEEL, ALPHA, N. J.

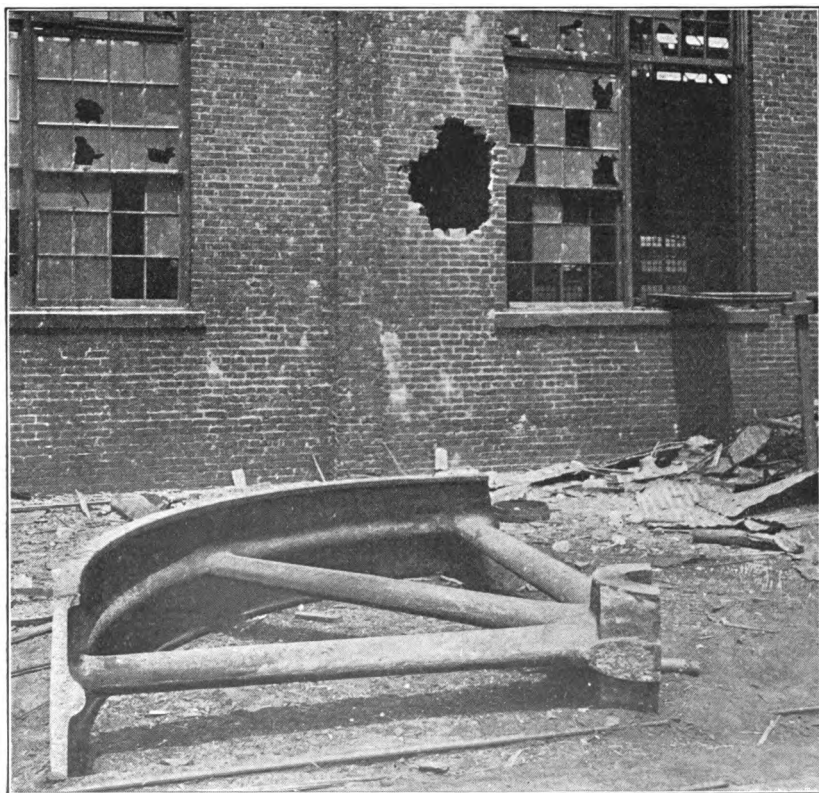
AN UNUSUAL FLY-WHEEL BREAK. BIRMINGHAM, ALABAMA.

A large fly-wheel burst Aug. 20 at the plant of the Payne and Joubert Machine and Foundry Co., Birmingham, Ala. The wheel, which was 15 feet in diameter, with a 26 inch face was of the split type, cast in two sections. It was joined at the rim by bolted flanges, and by the usual bolted construction at the hub. There were eight arms. The wheel served to transmit the load from an 18x36 inch Corliss engine to a generator, by means of a 24 inch belt. The speed was controlled by a fly ball governor of usual type, with a link type safety knock out, arranged for automatic operation in the event of governor belt breakage. The normal speed was 75 R. P. M.

We are told that a considerable peak load on the generator caused the circuit breaker to operate, relieving the engine very suddenly. The subsequent racing was noticed by the fireman and he called to the engineer who had stepped out of the engine room. The engineer, realizing what had happened, ran for the throttle, but only succeeded in getting in the path of one of the larger fragments of the wheel. He was instantly killed.

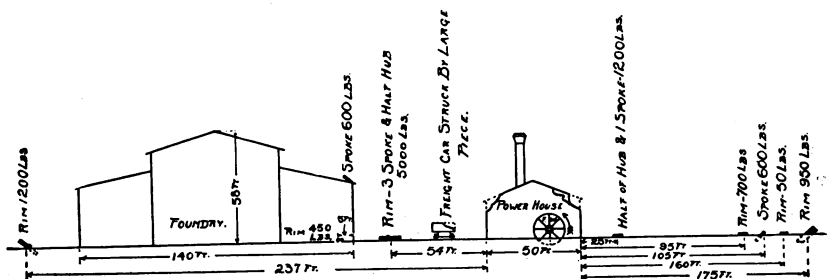
FIG. 1. SHOWING THE COURSE OF THE FRAGMENTS.

Portions of the wheel were thrown both in front and to the rear of the engine, as is shown in detail in our sketch, Fig. 1. The roof and walls of the engine room were badly wrecked, though the roof had been repaired when the photograph Fig. 2 was taken. One large piece passed completely through a gondola car that was standing on a siding alongside the engine room, as our sketch shows.

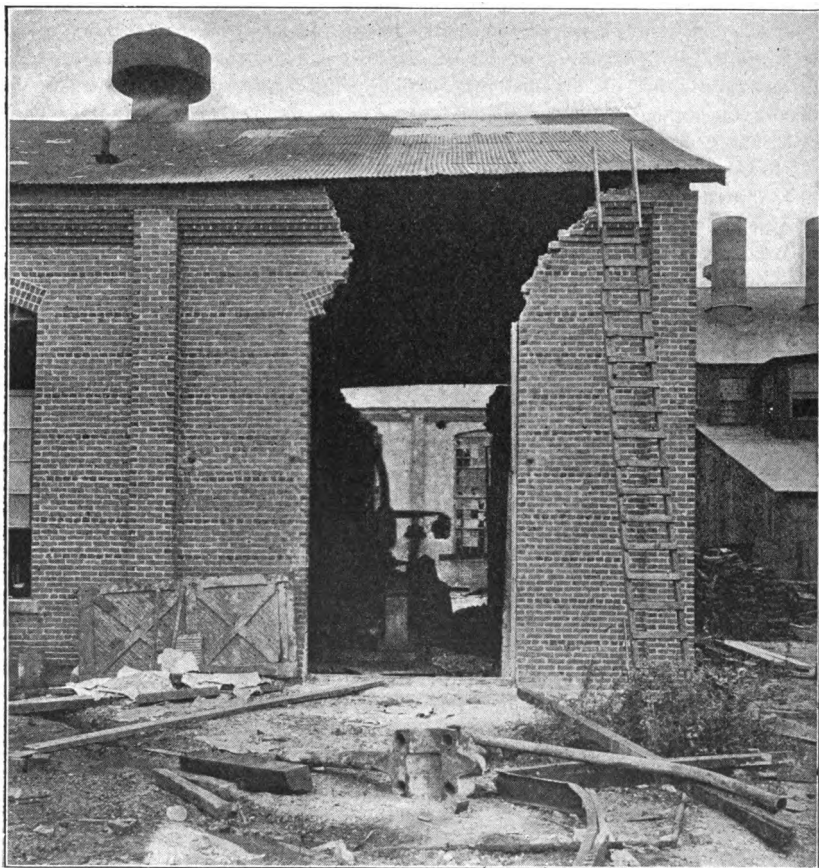
FIG. 2. THE WRECKED ENGINE ROOM.
